**Gippsland  
Water**

# **Annual Report**

on drinking water quality  
2023 - 2024

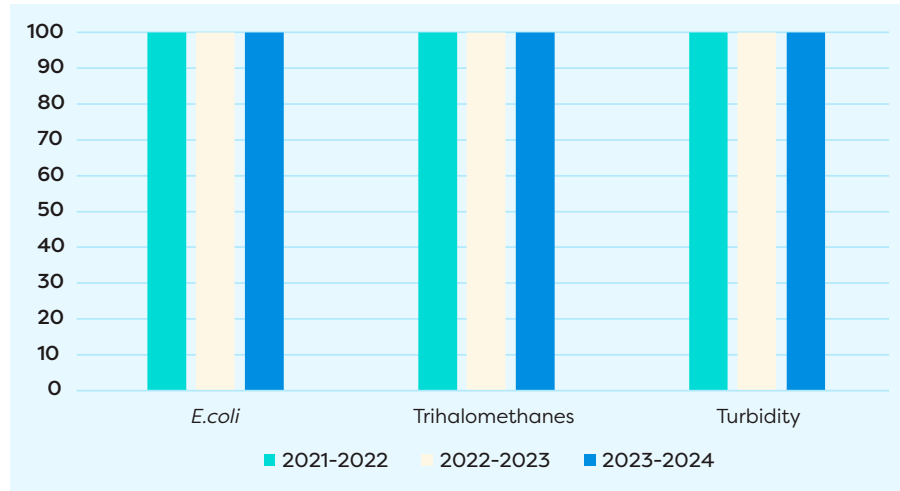
**Figure 7:** Percentage Compliance by Water Sampling Locality with Water Quality Standards – Schedule 2 (SDWR) 2015

For the 2023-2024 reporting period, 100% compliance was achieved with the Schedule 2 parameters. This result was equivalent to the 2021-2022 and 2022-2023 results, we are committed to delivering safe and high-quality standard drinking water to our customers.

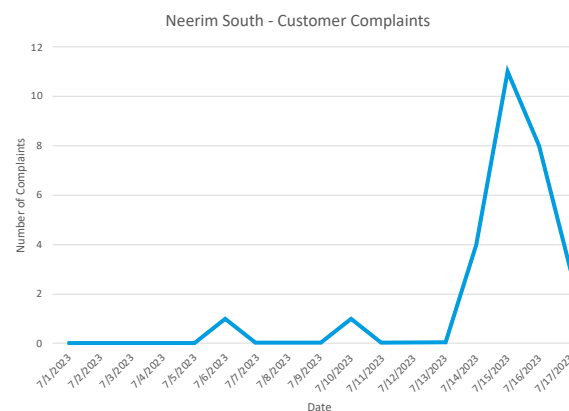
**Figure 10:** Neerim South customer complaints received between 1 July 2023 – 17 July 2023.

Due to the number of customer complaints received from Neerim South, 26 dirty water complaints, between 14 July 2023 and 17 July 2023, the Department of Health (DH) was advised, and a notification was submitted under Section 22 (1)(d), as required. Figure 10 below shows that number of complaints received from customers in the Neerim South reticulation for the period 1 July 2023 to 17 July 2023. As shown below, the customer complaints peaked during and immediately after the high flow spikes.

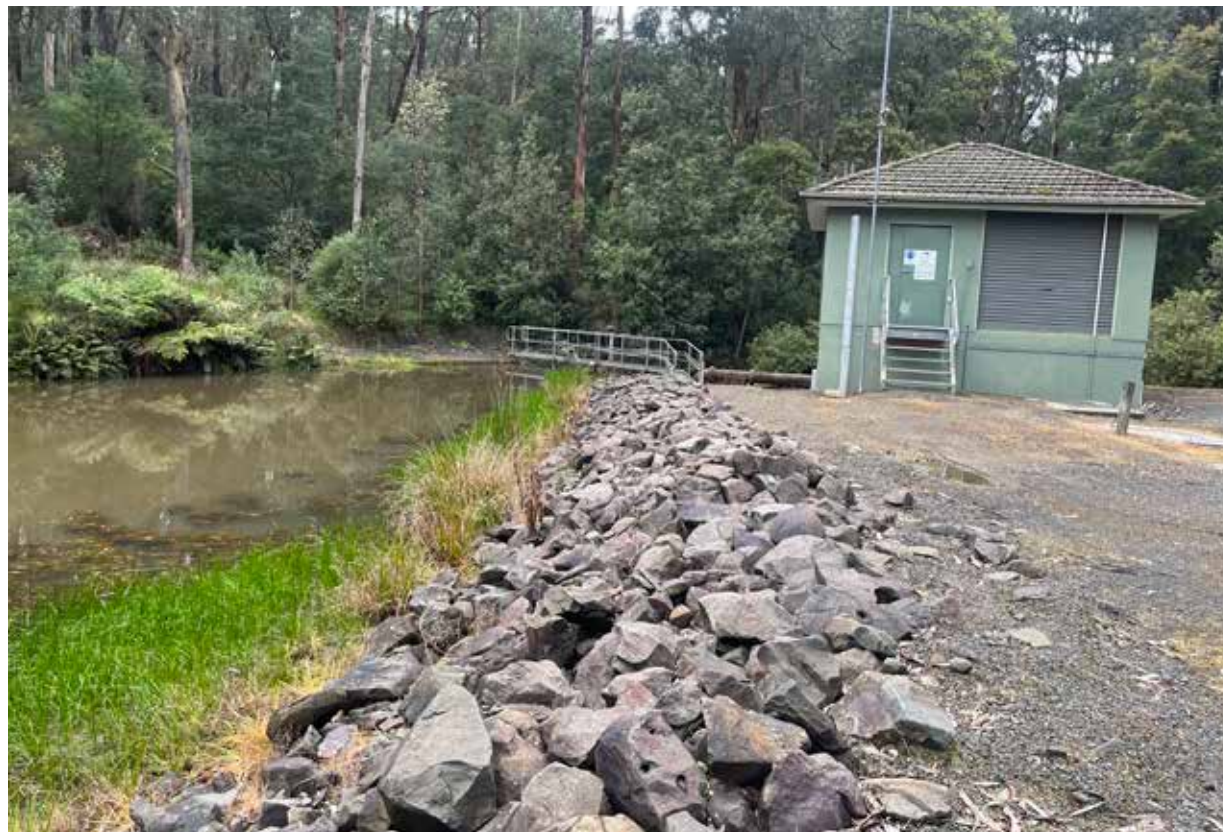
**Figure 12:** Morwell High Level Water Supply System

With the pumps unable to operate, the elevated tower drained down through customer usage, resulting in a low level in the tower. This low water level reduced the pressure in the system, resulting in customer experiencing issues with their water supply.
